## System Update Notice

Following a system change notice notifications for the BalanceTutor BT100 product:

### 1. Change notice 29 Sep 2020

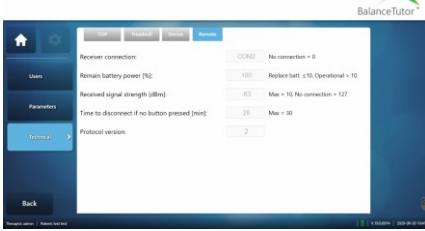
Product assembly  BalanceTutor technical specification: DO-15-01-01_200929
3.	- Adding Remote TAB in application settings - Shows few parameters about remote controller connection to the computer system	New feature

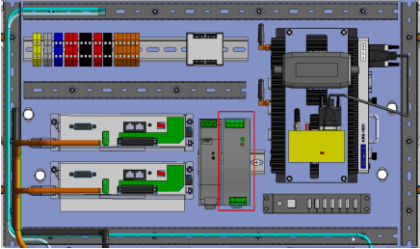
Application Version 19
4.	12V power supply changed from 75W to 120W	Avoid over heat due to power consumption

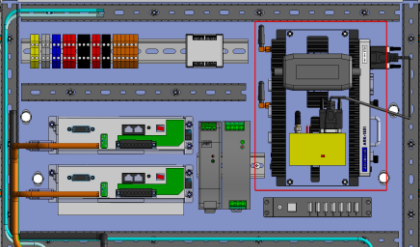
Product assembly
5.	Changing computer from ARK1550 to ARK1551	Upgrade to 8 <sup>th</sup> generation CPU

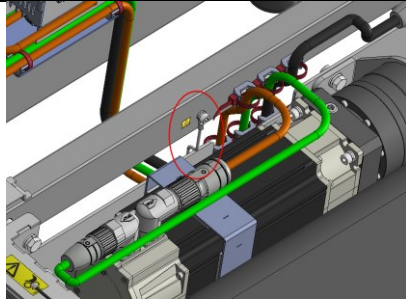
Product assembly
7.	Adding grounding cable perturbation frame and front motor house	Remove grounding cable between perturbation frame and base frame

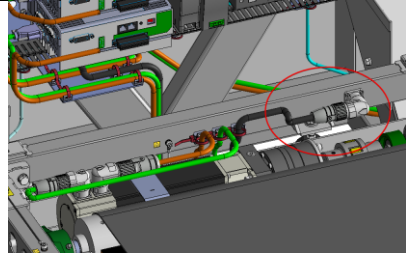
8.	Changing COP cable connector from left to right side	<ul style="list-style-type: none"> <li>- Cable management</li> <li>- Comfortability during assembly</li> </ul>

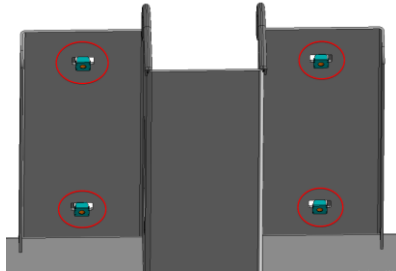
9.	Changing from HEX Rivet nut to Cage Nut	Adjustment ability during wings assembly

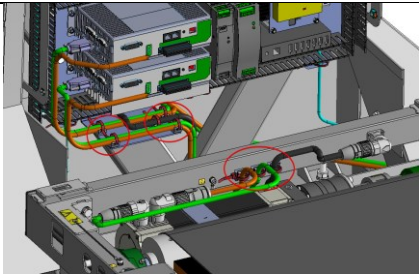
OS Microsoft License  BalanceTutor technical specification: DO-15-01-01_200929
15.	Adding cable tie mounts	Cable management

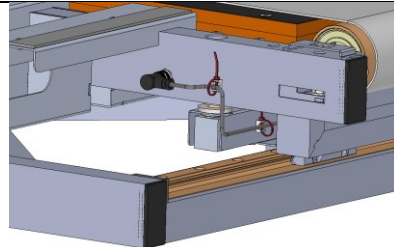
4.	Changing 4 load cell connectors from Molex Mini-Fit type to M12 rotational lock right angle connectors.	Connector reliability.

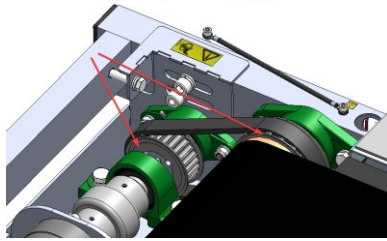
10.	Changing rollers with Bushing principal adjustment	Assembly accuracy, reliability for long life of the transmission system.

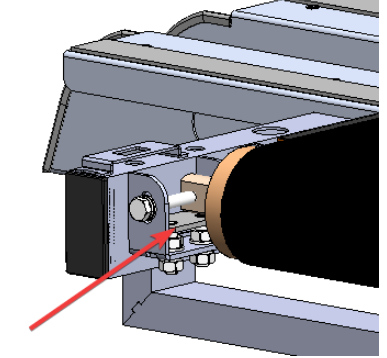
12.	Adding adjustment ability of the back pulley.	Adjustment ability in case of belt misalignment with the wood board.
