BalanceTutor™ Service Manual

BalanceTutor a dynamic and static postural control trainer

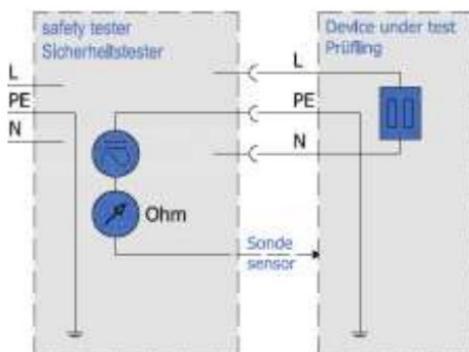
4.3.2 Protective earth resistance (R_{PE}) measurement

- Resistance between housing and protective earth connection.
- The low resistance pass is to be controlled according to VDE 0701/0702 (sports and fitness machines) or VDE 0751/IEC 60601-1 (medical devices) by the protective resistance measurement with a measuring device for the protective earth resistance measurement.
- The connecting lead is to be moved while measuring for at least 5 sec. If the resistance thus changes, it is highly probable that the cable or the connectors have been damaged. In this case the cable should be replaced and the device repaired immediately.

- Limit value $< 0.3 \Omega$

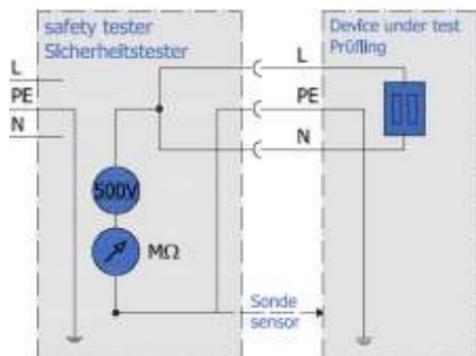
4.3.3 Isolation resistance (R_{ISO}) measurement

- Resistance between „bridged“ L+N and Protective Earth connection.
- Make sure that all isolations that are under stress of the mains voltage, are considered. All switches and contactors need to be connected.
- The measurement need to be performed with measuring devices for the isolation resistance measurement according to VDE 0701/0702 (sports and fitness machines) or VDE 0751/IEC 60601-1 (medical devices).
- Limit value $> 2.0 M\Omega$

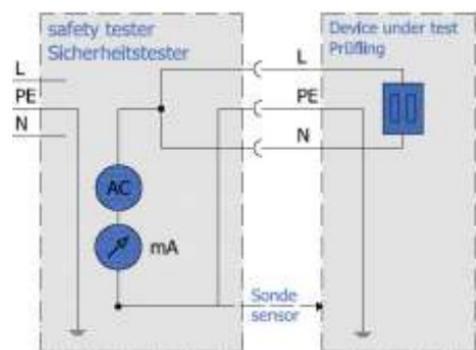
4.3.4 Equivalent (alternative) leakage current (I_{EDL}) measurement

- Impedance measurement, indicating the current in the protective earth cable
- The measurement is to be performed by a measuring device for leakage current measuring according to VDE 0701/0702 (sports and fitness machines) or VDE 0751/IEC 60601-1 (medical devices).
- The measurement is equivalent to the single fault earth leakage current based on IEC 60601.
- Limit value $< 0.5 \text{ mA}$

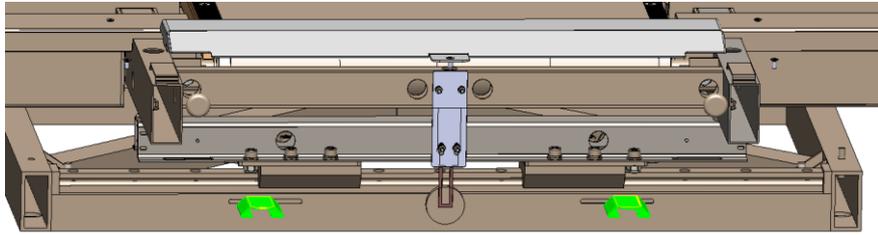
4.3.6 Limit switch safety operation

Purpose	Checking if at maximal lateral perturbation the limit switch does not activated.
Procedure	<p>Access to Setting → Technical → Treadmill → Press 21.75, -21.75 → Apply</p> <p>The limit switch <u>should not</u> be activated, if yes adjust the limiters locations.</p>

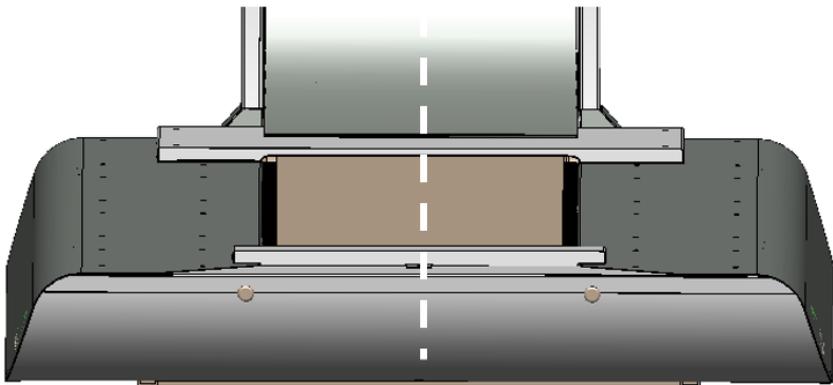
4.3.7 Homing process conducted correct

Purpose	Confirm perturbation plate return to physical zero of the device after Homing command.
Procedure	<p>Access to Setting → Technical → Treadmill → Press Homing.</p> <p>Confirm after Homing the perturbation plate returns to the center for the device.</p>

<p>If the plate do not returns to the exact center location, please consult with MediTouch.</p>

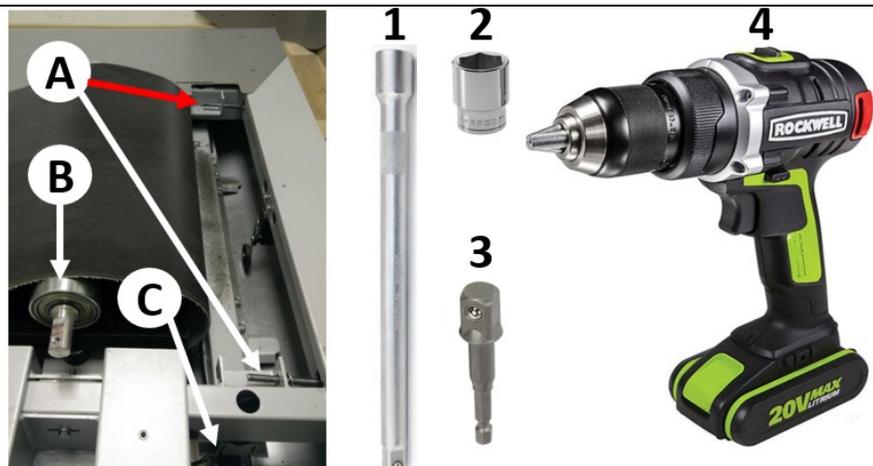
6.1.2 Back pulley release

A. Release two M10 bolts from pulley.

Note:
BE CAREFUL NOT DAMAGE THE INNER CABLE LOCATED IN THE RIGHT HOLE.

- B. Place the pulley on top of the running board
- C. Cut black cable tie

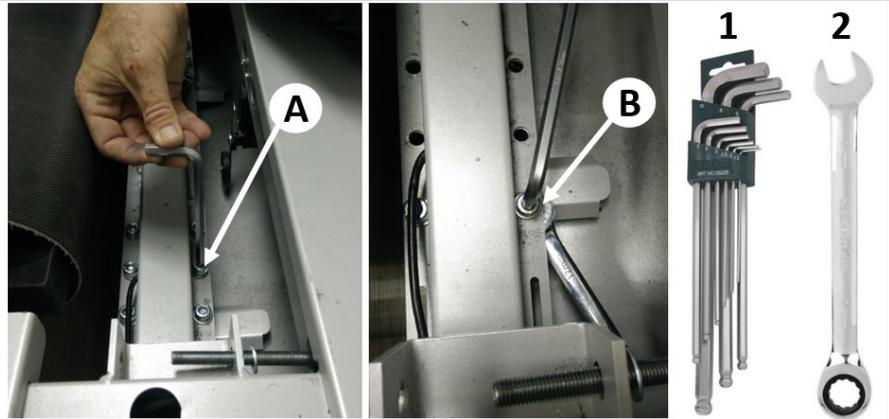
6.1.3 Sensor plate bolts release

- A. Release 4 bolts
- B. Release two bolts + nylock nuts

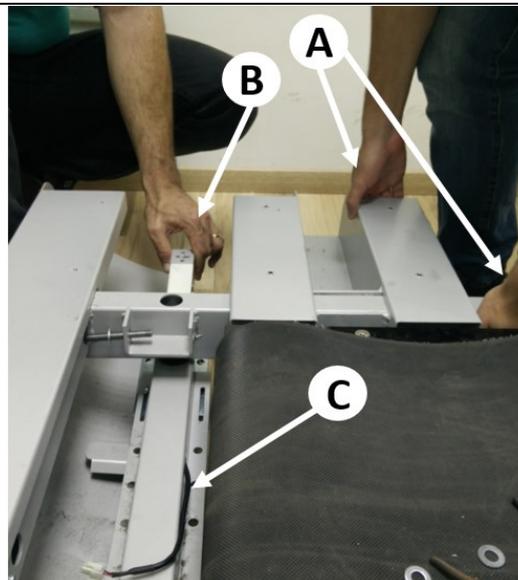
6.1.4 Sensor plate release

- A. Lift no more than 1-2cm the upper frame
- B. Pull the sensor from its position
- C. Pay attention sensor cable released from here

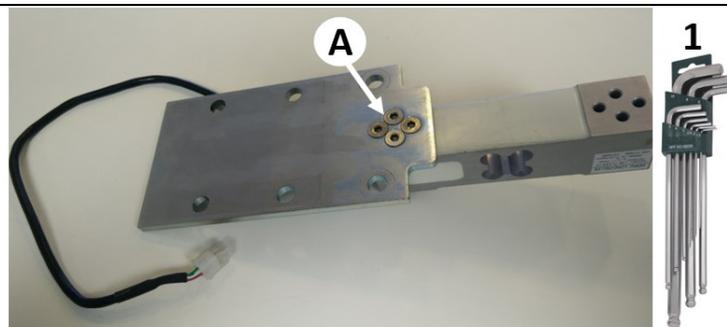
6.1.5 Sensor replacement

- A. Replace sensor according orientation described in the image

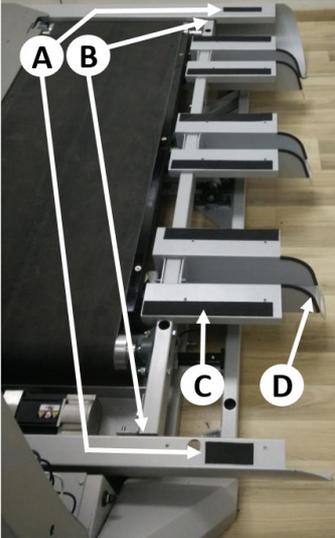
6.2.2 Foam and Profile placement

<p>A. Attach Foam 15cm – 4pcs</p> <p>B. Attach Foam 4cm – 4pcs</p> <p>C. Attach Foam 38cm – 12pcs</p> <p>D. Assemble Profile 13cm – 12pcs</p>

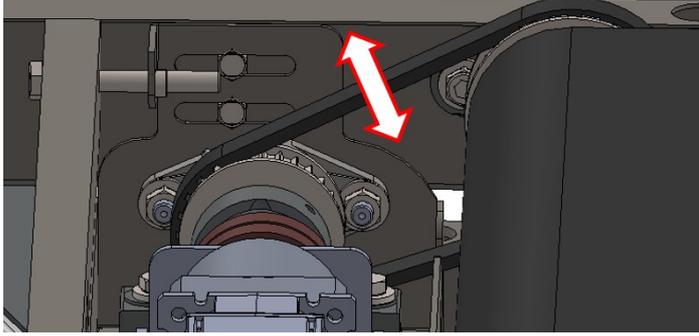
6.3.1 Case 1 - Timing belt tightness

<p>Indication</p>	<p>Tightness of the timing belt is too loose or tight. Approximately more or less than $\pm 0.5\text{cm}$ when you pull and push the belt to its vertical axis.</p>

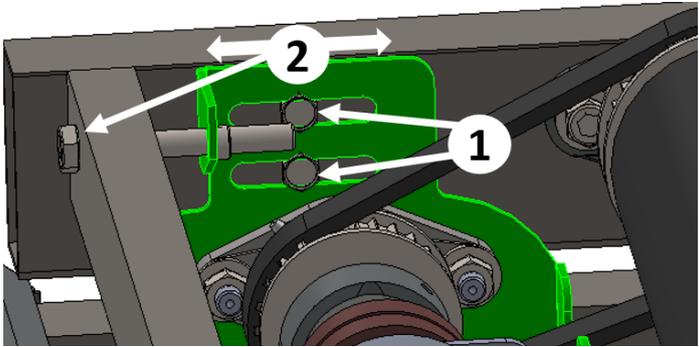
<p>Corrective actions</p>	<p>(1) Release a little bit the two bolts (of each side of the motor house) (2) Adjust timing belt to have a ripple of no more than $\pm 0.5\text{cm}$ of its horizontal axis.</p>

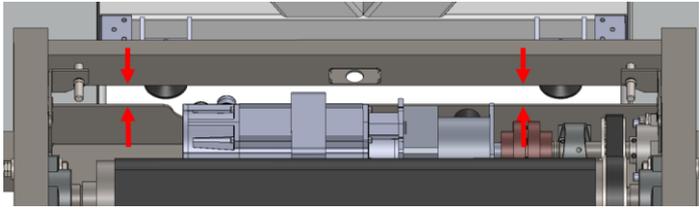
<p>Make sure that the motor house parallel to front frame bar.</p>

<p>After tension confirmation tight, the bolts back.</p>

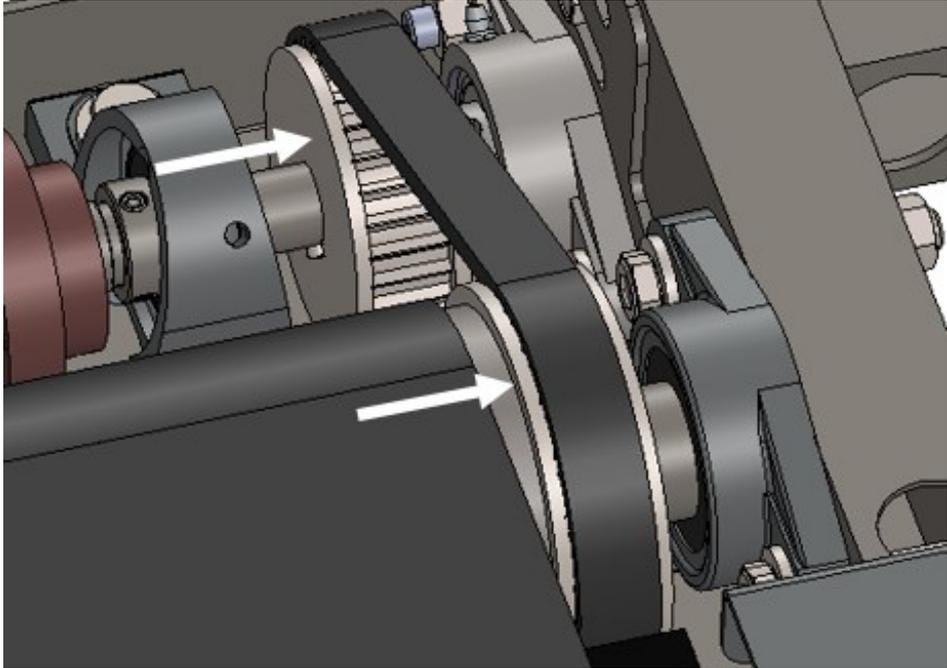
6.3.2 Case 2 - Front transmission alignment

Indication	Components are not parallel; Timing Wheels, Front pulley, etc.
Corrective actions	<p>Confirm that the following cases;</p> <ol style="list-style-type: none"> 1. Timing wheels must be parallel one each other.

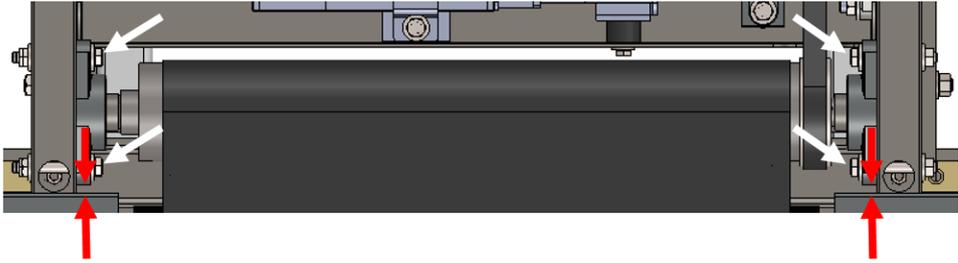
<ol style="list-style-type: none"> 2. Confirm Pulley is parallel to the front Rib (red), if no adjust using bearing release bolts (white).

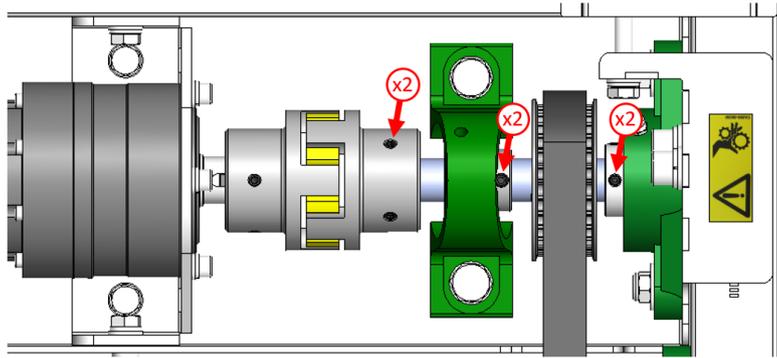
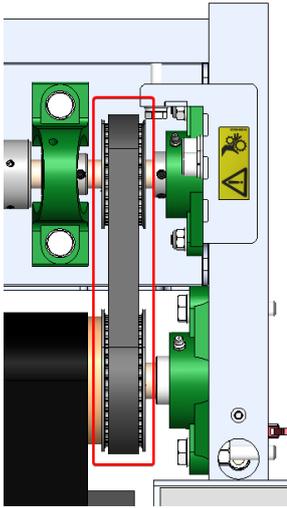
6.3.3 Case 3 – Cracking sounds in front transmission

Indication	Cracking sounds (high frequency) in a non-periodic manner during front motor operation.
Reason for error/fault	Axial tensions, dry components that has mechanical interaction
Corrective actions	<ol style="list-style-type: none"> 1. Release all marked setscrews <div data-bbox="507 562 1284 920" data-label="Image">

</div> 2. Run the treadmill in different speeds for few minutes. 3. During motor operation, lubricate using silicon spray or WD-40 all transmission-moving parts including shaft and its interfaces to the bearings. 4. Confirm the two black rollers assembled with the drive belt are vertically aligned one each other before tightening back the setscrews. <div data-bbox="507 1279 794 1787" data-label="Image">

</div> 5. Confirm cracking sounds gone then lock back all released setscrews. 6. Confirm again cracking sounds gone after locking all setscrews.

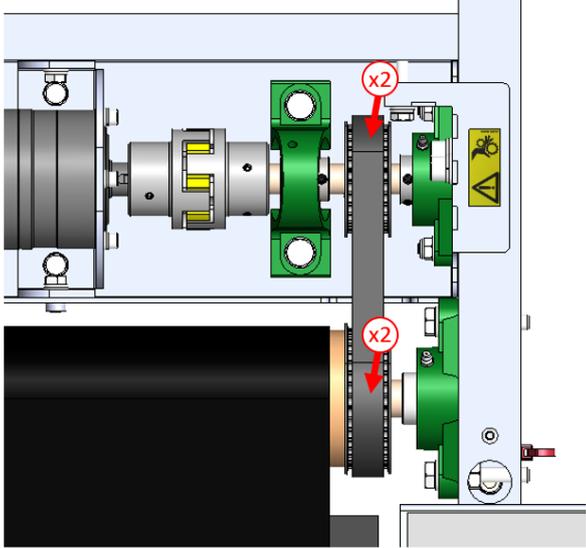
6.3.4 Case 4 – Knocking sounds in front transmission

Indication	Semi-periodic metallic knocks during front motor operation
Reason for error/fault	Setscrews in the two drive belt rollers are released Relevant to BT versions up to serial number A183000058
Corrective actions	<ol style="list-style-type: none"> 1. Confirm all setscrews are tightened and secured with additional added Loctite type 242

<ol style="list-style-type: none"> 2. Run the treadmill in different speeds for few minutes. 3. During motor operation, lubricate using silicon spray all transmission-moving parts.

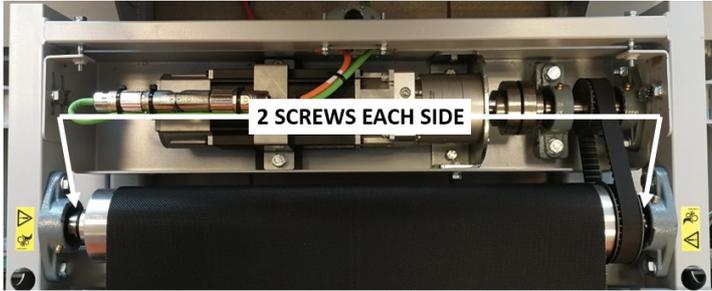
Hex key #3
2. Release two screws located on each bearing

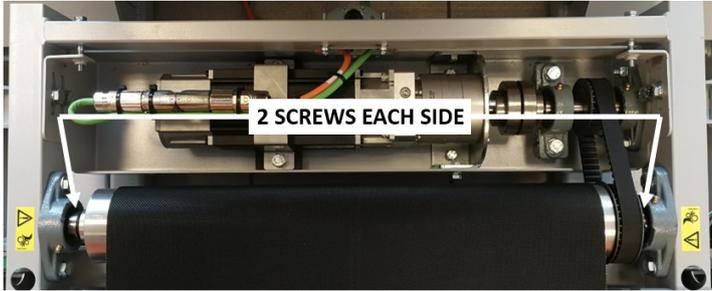
Hex key #2.5
3. Turn ON the system and let the front motor run on maximal speed for 5 seconds.		
4. Tighten back the two screws located on each bearing

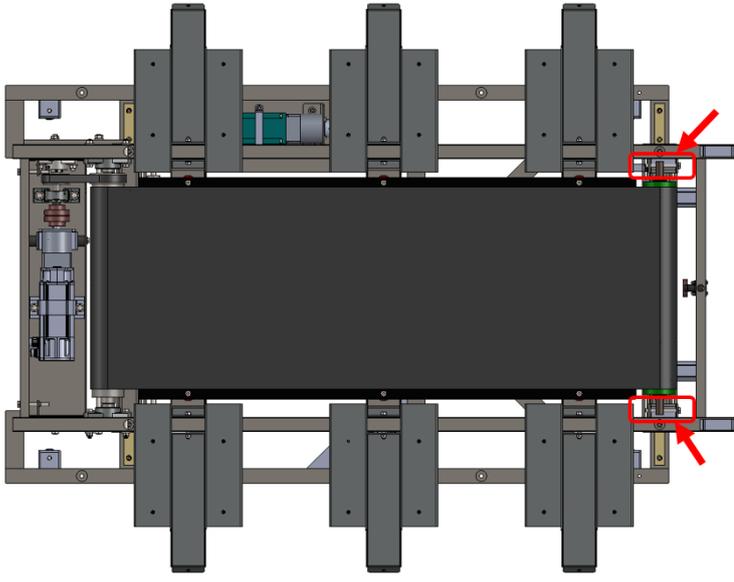
<p>1. Release the two bolts</p>

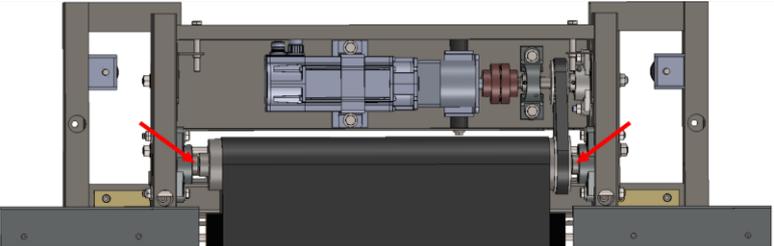
<p>T Handle Socket 17x230mm</p>
<p>2. Release the locking hex black bolts in the bearings</p>

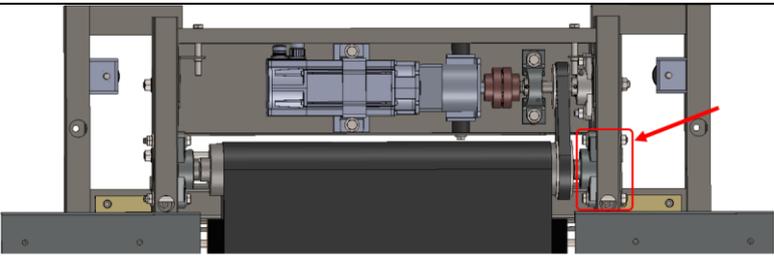
<p>Hex key #3</p>
<p>3. Remove two bolts holding the bearing</p>

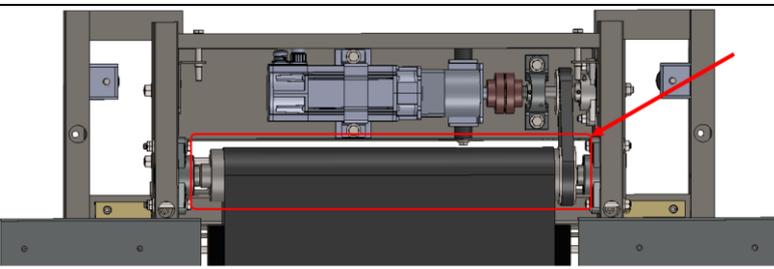
<p>2pcs Wrench 17mm</p>
<p>4. Remove the front pulley and replace it including the black timing wheel</p>

<p>5. Perform adjustment procedure as describe in section 8.3.2 for the front pulley, and close all components as described in this section from last to first.</p>

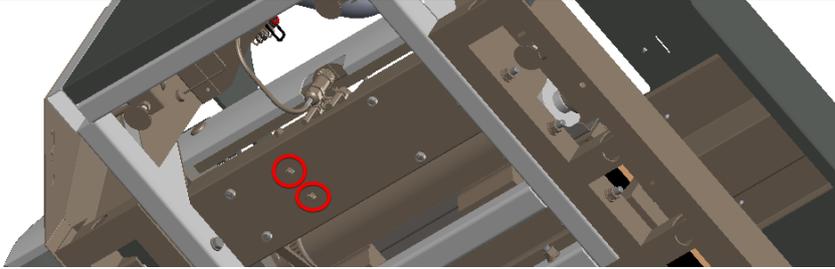
1. Remove two M10 bolts from bottom of the motor house.

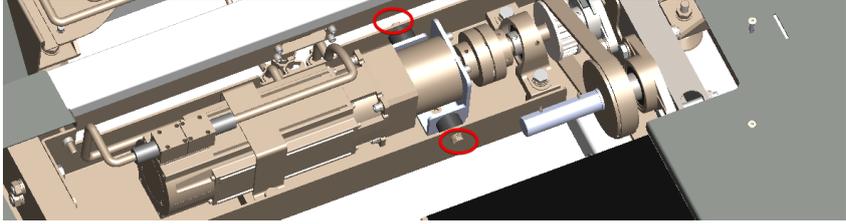
2. Remove two M10 bolts from the side

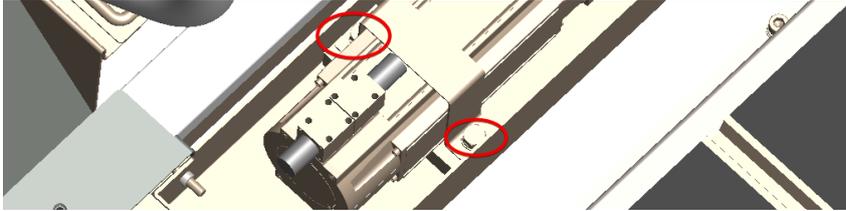
Reversible Wrench 17mm
3. Remove two M10 bolts that closes the motor from top

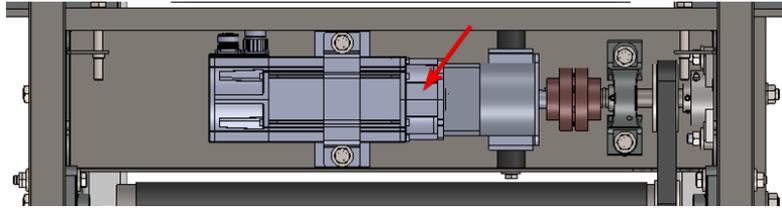
4. Disconnect the motor from the gearbox

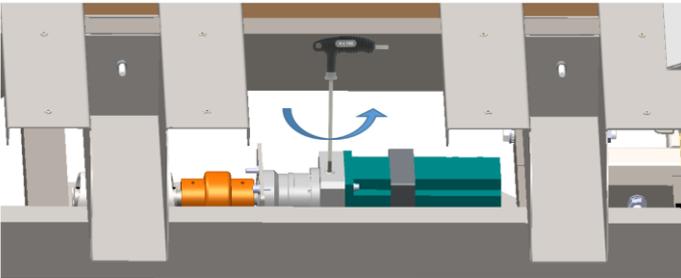
Hex key #3
2. Remove THREAD CAP

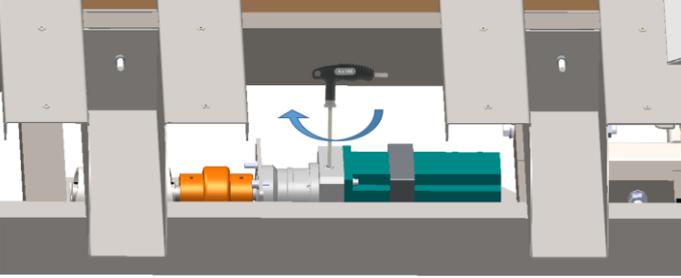
Hex key #6
3. Tighten the inner clamping bolt

Hex key #3
4. Confirm the platform locked after turning ON the system and completing the homing procedure. Assemble all parts with reverse order.

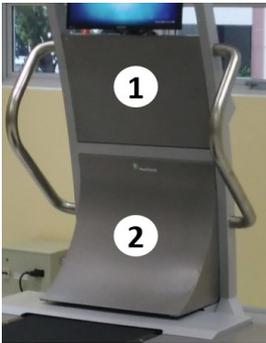
Indication	Damaged cable or connectors
Corrective actions	<p>A. Prepare the following cable: “Cable HDMI to DVI 1.8m Black”</p> <p>B. Remove covers 1+2</p>

<p>C. Replace carefully the cable with a new (white dashed route)</p> <div style="display: flex; justify-content: space-around;"> <div data-bbox="557 891 991 1182"> <p>TYPE 1 BOARD</p>

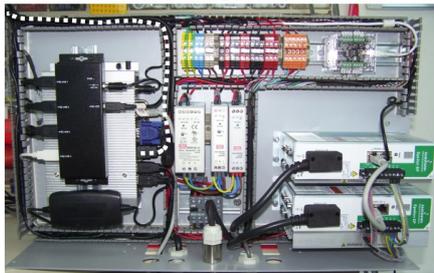
</div> <div data-bbox="1002 891 1430 1182"> <p>TYPE 2 BOARD</p>

</div> </div> <p>D. Restart the system and press channel selection on the patient screen to detect the DVI connection channel</p>

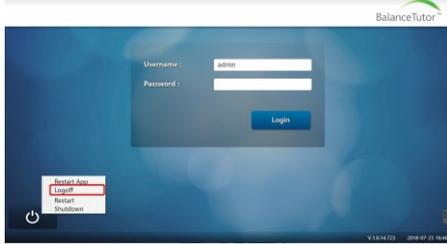
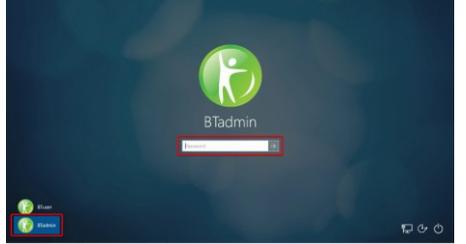
<p>1. Logoff the application and enter as Btadmin user</p>
